**CALSPAN ON-SITE INVESTIGATION OF TWO COMPRESSED NATURAL GAS
(CNG) CYLINDER RUPTURES
CALSPAN CASE NOS. 94-19 AND 94-20**

VEHICLES - TWO 1992 GMC SIERRA 2500 PICKUP TRUCKS

**CALSPAN CASE NO. 94-19 AND CASE NO. 94-20
COMPRESSED NATURAL GAS CYLINDER FAILURES
1992 GMC SIERRA 2500 SERIES PICKUP TRUCKS**

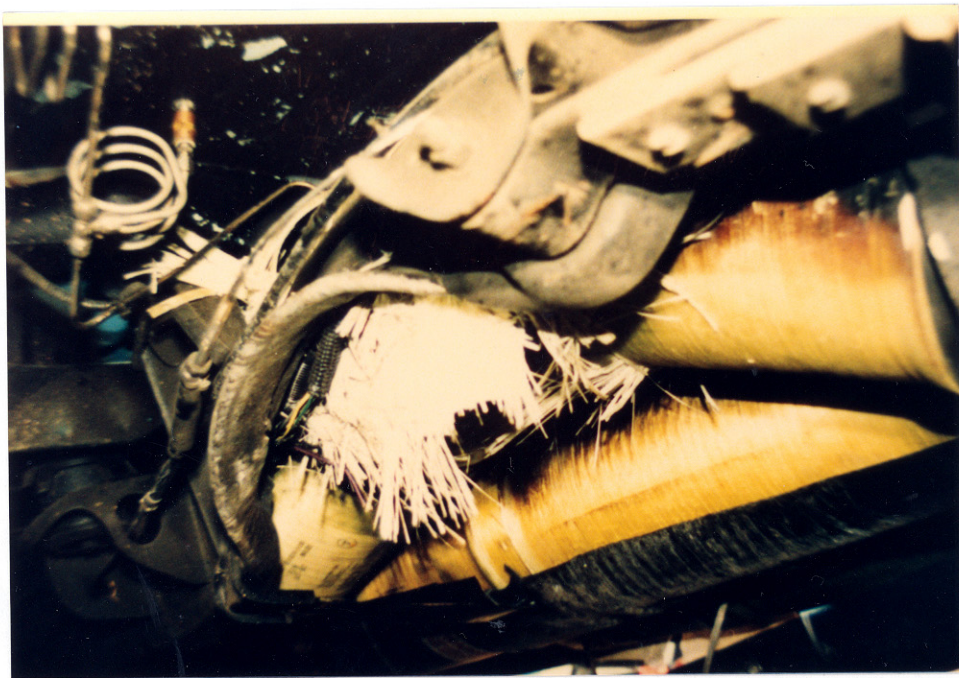
4. Undercarriage View of the Damaged Left Frame Rail at the Scene

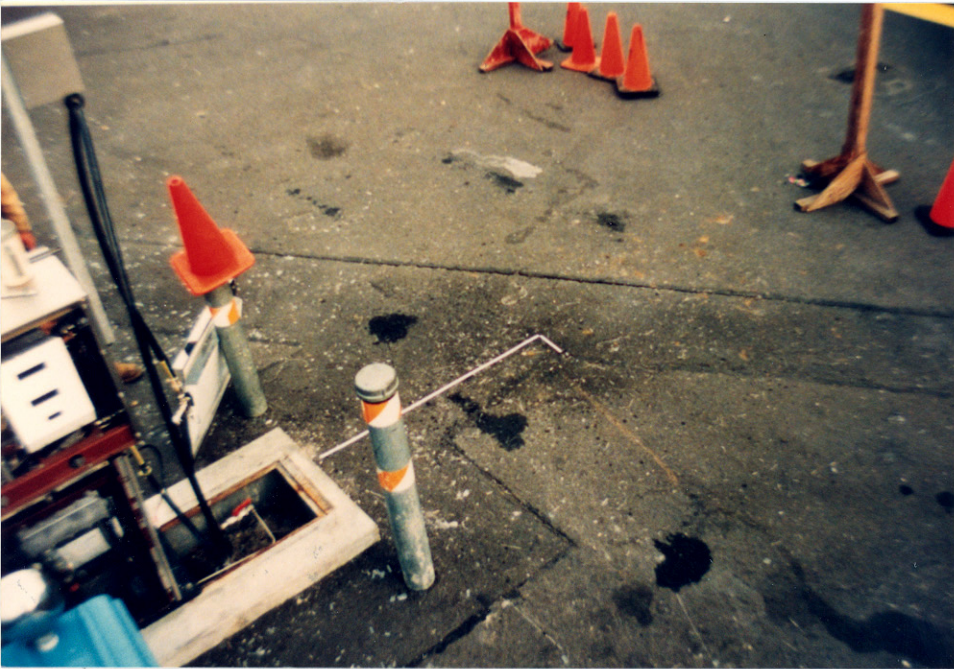
5. Damaged CNG Fuel Pump and Scattered Debris

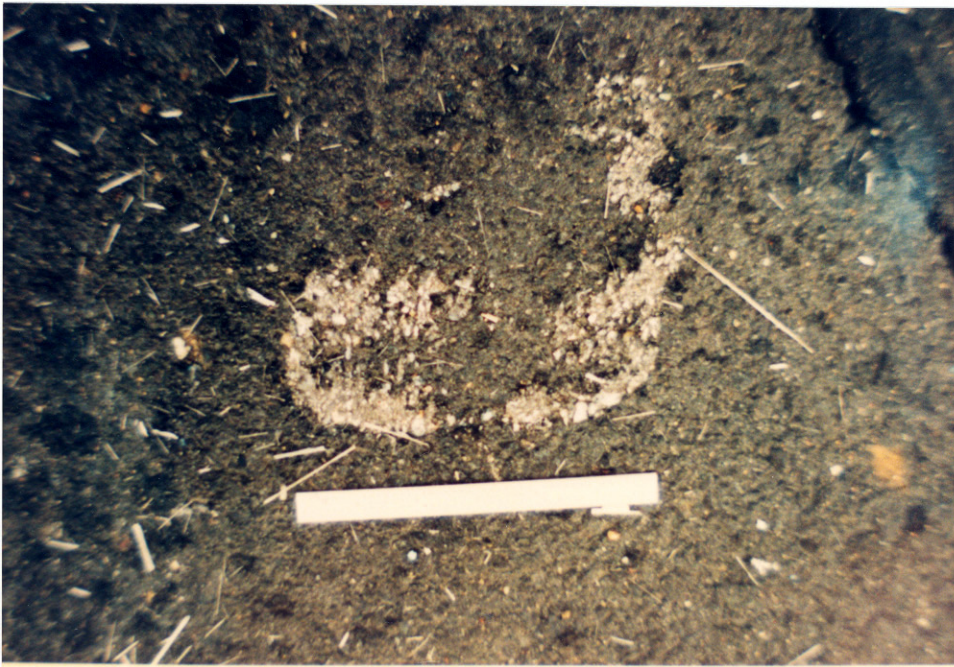
6. Cylinder Liner Fragment Impact with Asphalt Surface

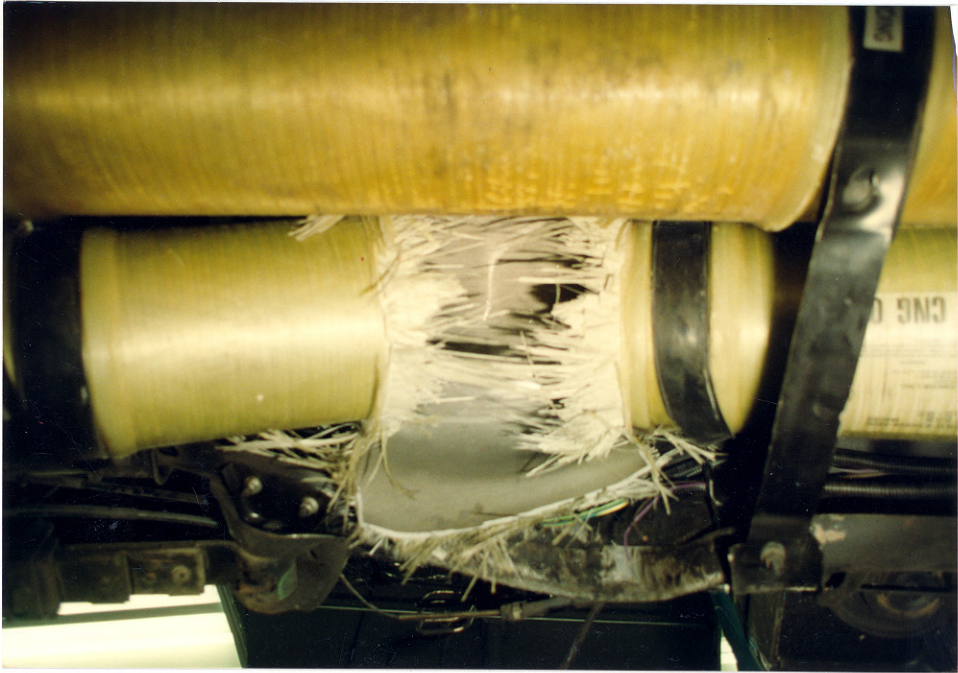
11. Undercarriage View of the Ruptured Cylinder and Resultant Damage to the Left Frame Rail and Inboard Cylinder HDPE Shield

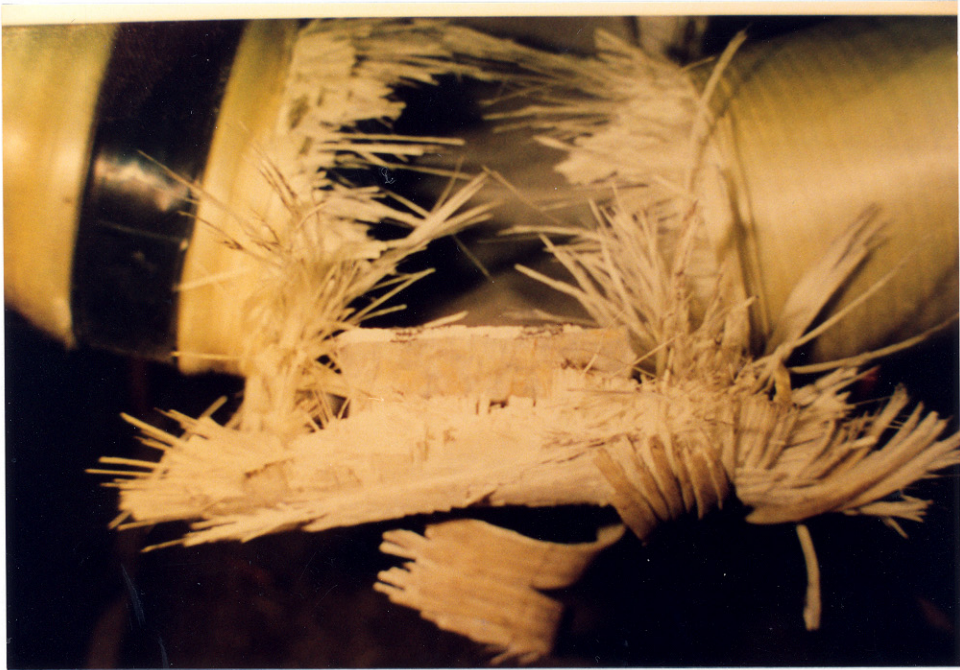
12. Closeup View of the Rupture Location

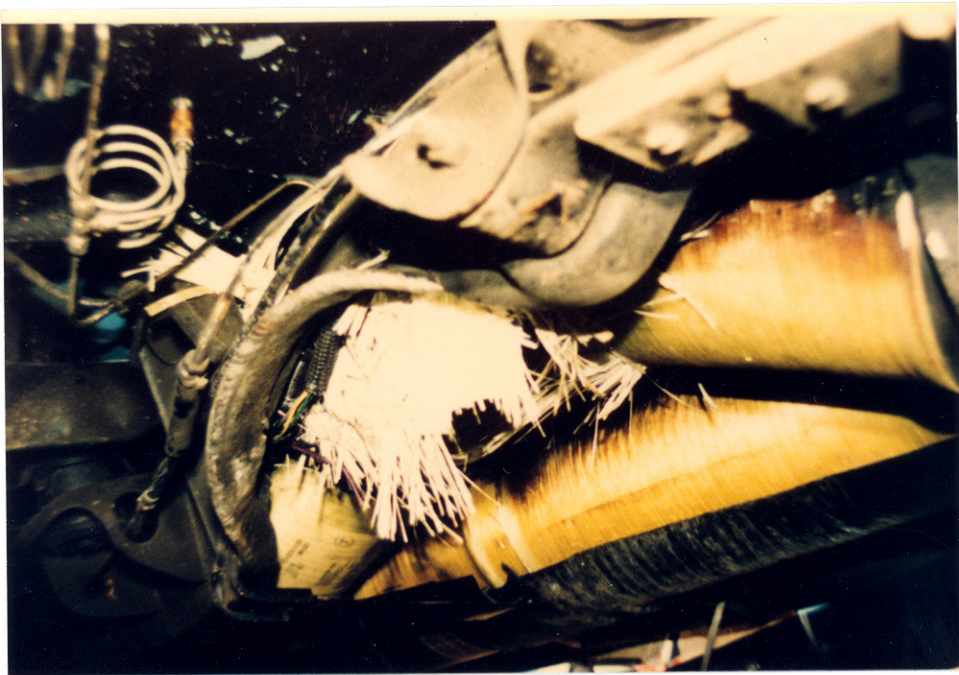
13. Closeup Views of the Resultant Frame Deformation

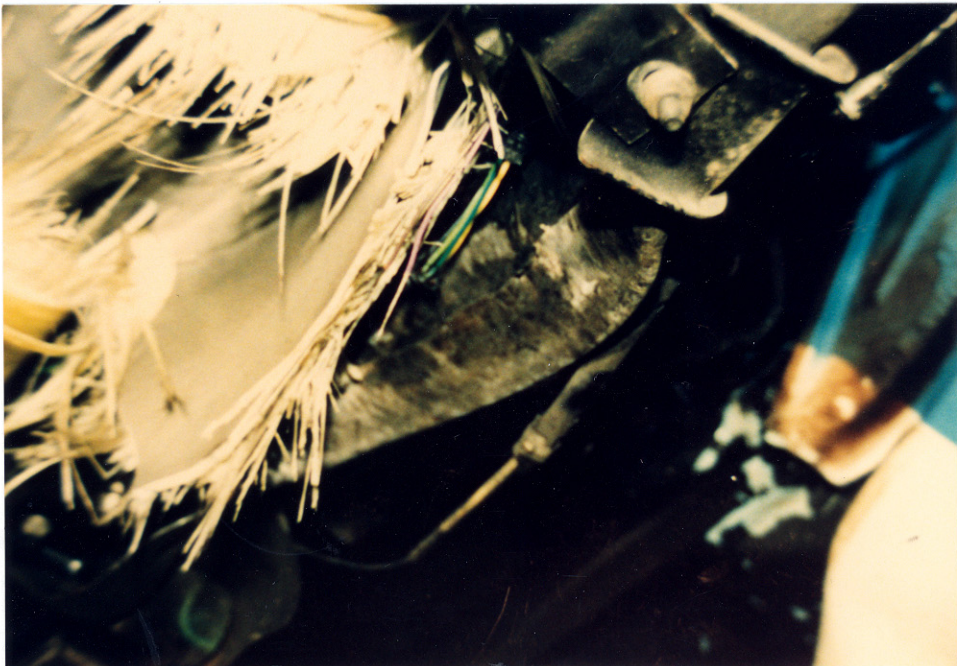
16. Closeup View of the Cylinder Flap and Frame Rail Deformation

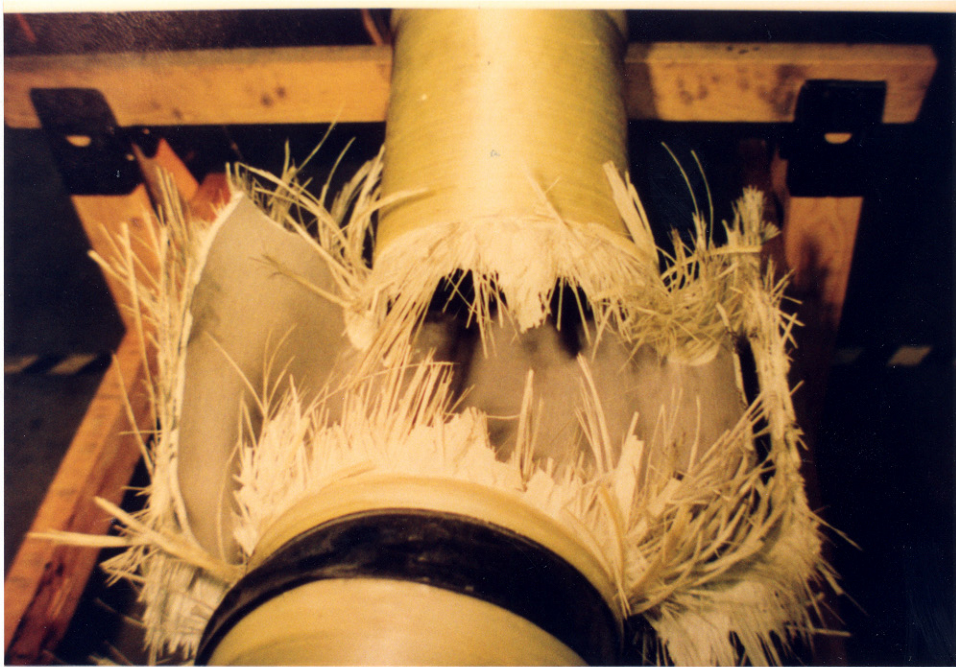
The rupture pattern of the CNG cylinder resembled an "H" configuration with the crossbar of the "H" aligned longitudinally with respect to the length of the cylinder and the remaining segments of the "H" oriented circumferentially. The rupture pattern opened outward with the aluminum liner forming two lateral flaps (i.e. bomb bay door fashion). The rupture site occurred along the downward facing surface of the cylinder which resulted in an upward deflection of the cylinder near the longitudinal center of the cylinder. The deflection angle of the cylinder was calculated at approximately 16° at its resting position in the cradle following removal from the vehicle. The forward circumferential rupture point of the aluminum liner was located 56.5 cm (22.25") rearward of the cylinder's leading end as referenced to the junction of the fiberglass wrap with the boss. The fiberglass wrap along the forward circumferential fracture line was located 48.3 cm (19.0") rearward from the same reference point. The rearward circumferential rupture point of both the aluminum liner and fiberglass wrap was located 61.0 cm (24.0") forward of the rear of the cylinder as referenced to the junction of the fiberglass wrap and rear boss.

21. Longitudinal View of the H-Configuration Rupture Location

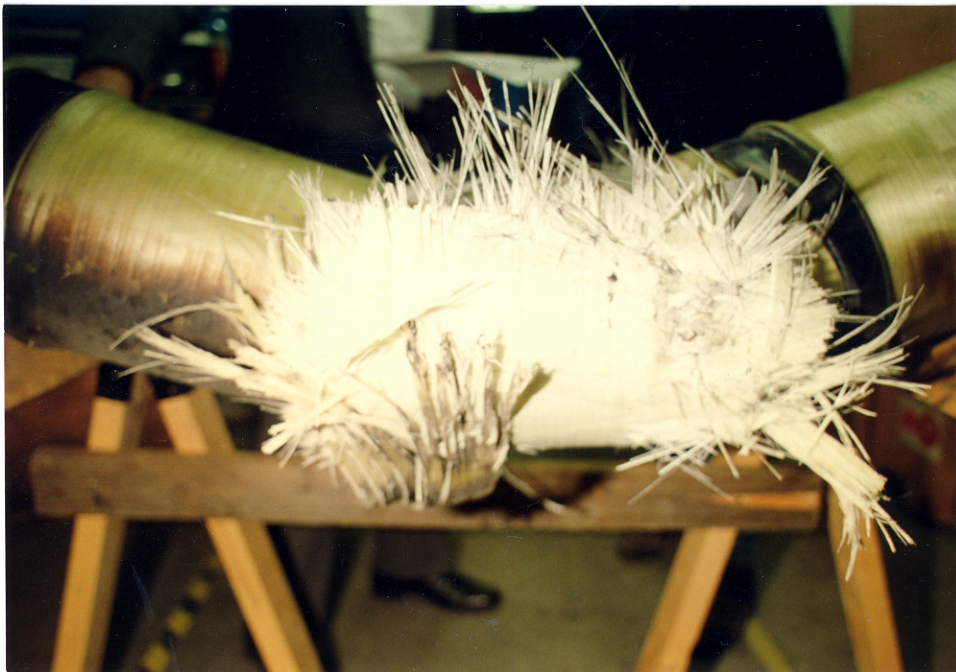
22. Outboard Side of the Separated Fiberglass Wrap

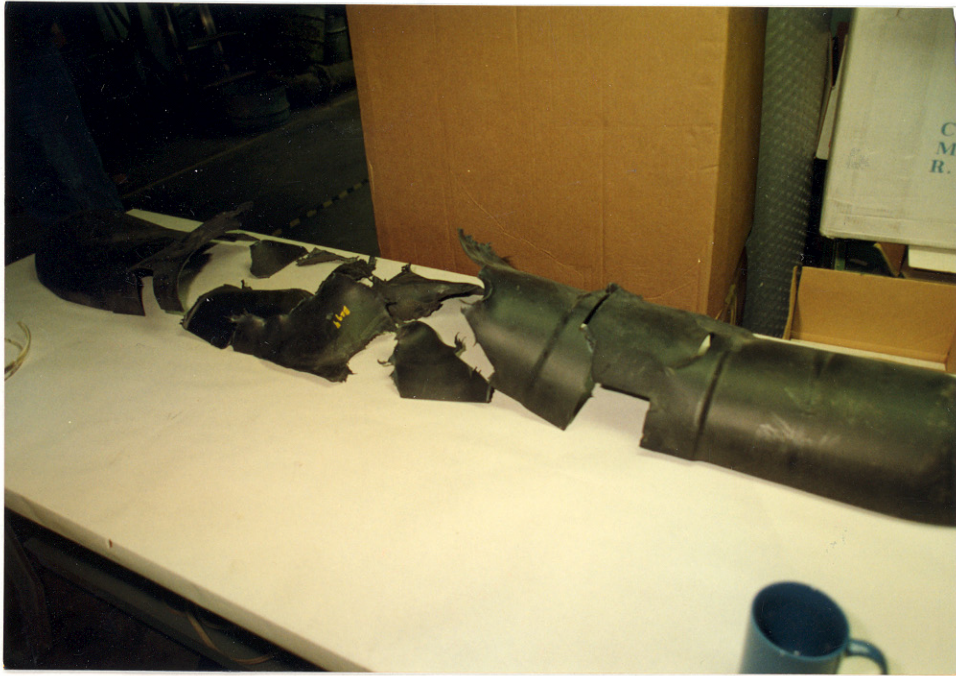
The center of the protective HDPE shield which was attached to the bottom of the CNG cylinder by three stainless steel straps was shattered into six pieces during the rupture sequence. The HDPE shield over the adjacent center CNG cylinder exhibited fiberglass transfers from the right flap of the ruptured CNG cylinder. It also experienced a 2.5 cm x 1.3 cm (1.0" x 0.5") wide puncture near the longitudinal edge of the fiberglass transfer along the bottom of the shield.

25. Shattered HDPE Shield from the Ruptured Cylinder

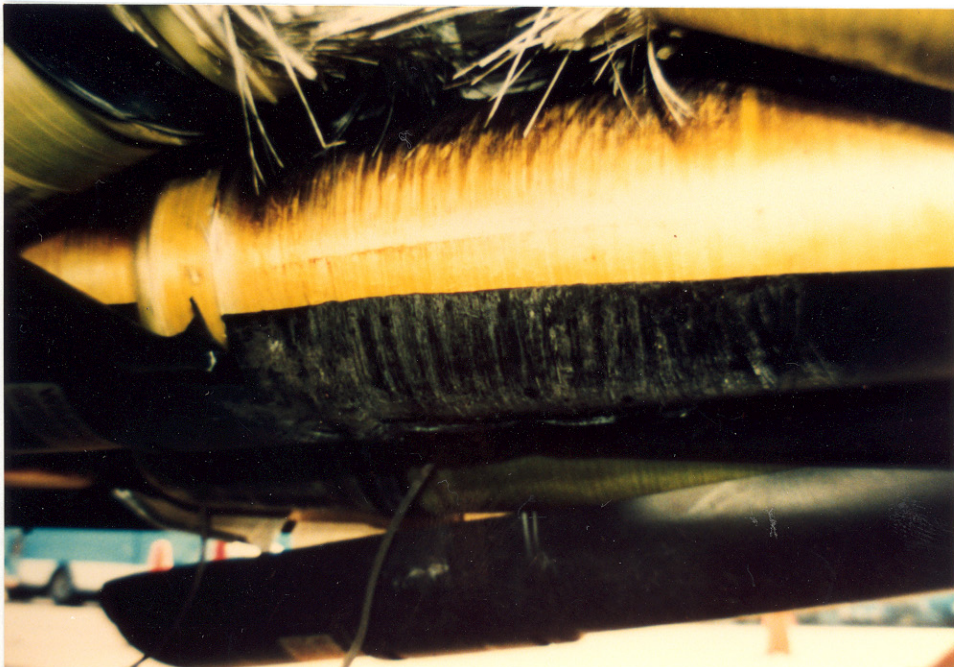
26. Contact Damage to the Center Cylinder and HDPE Shield

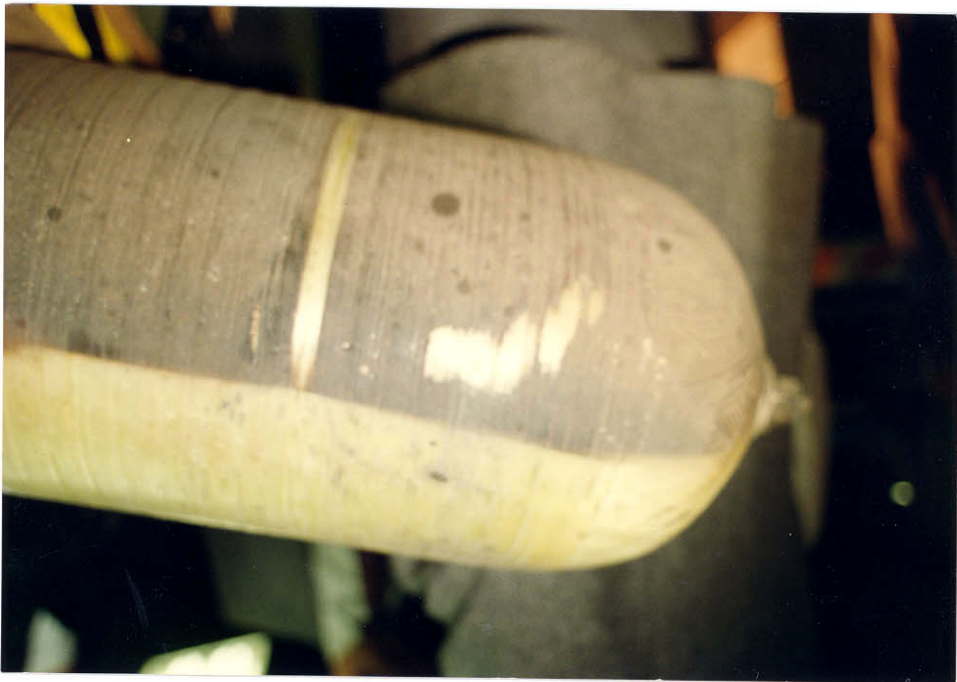
28. Brake Cable Rub Mark on the Rear of the Ruptured Cylinder

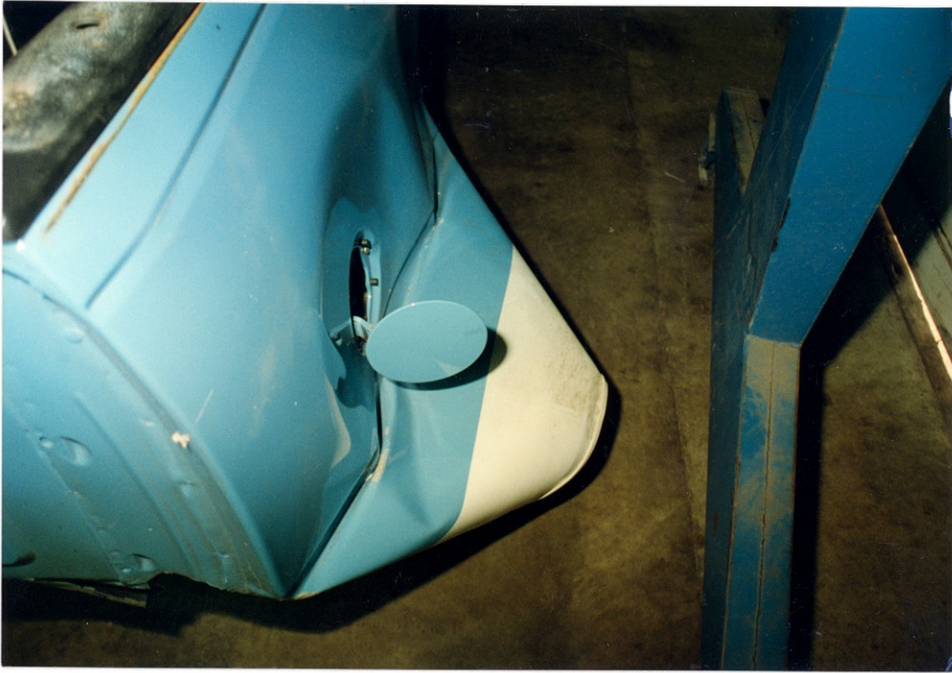
31. Outboard Deflection of the Left Lower Quarter Panel Adjacent to the Rupture Location

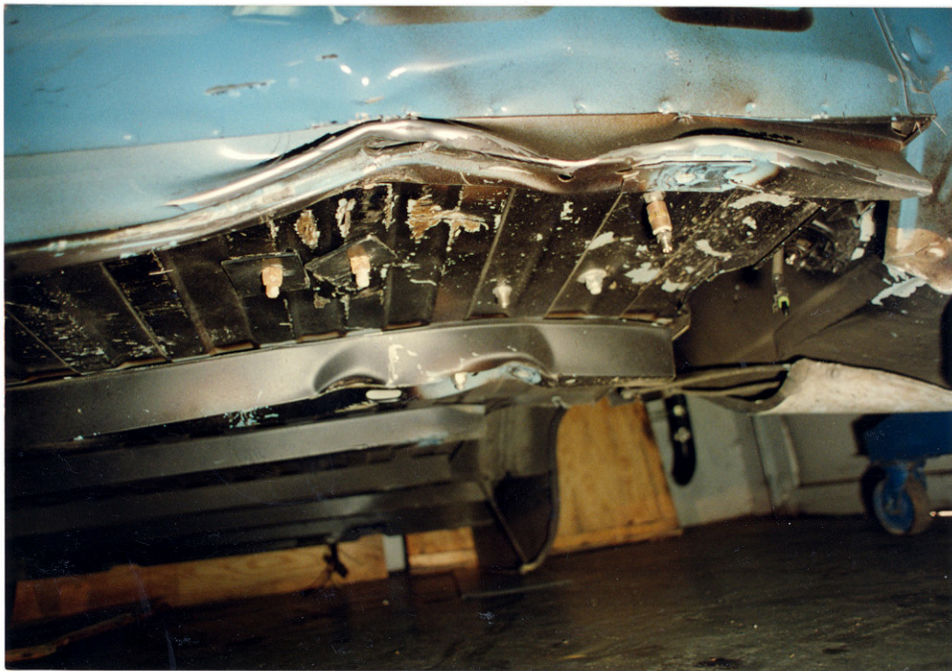
32. Damage to the Floor and Crossmembers of the Cargo Box of the Pickup Truck

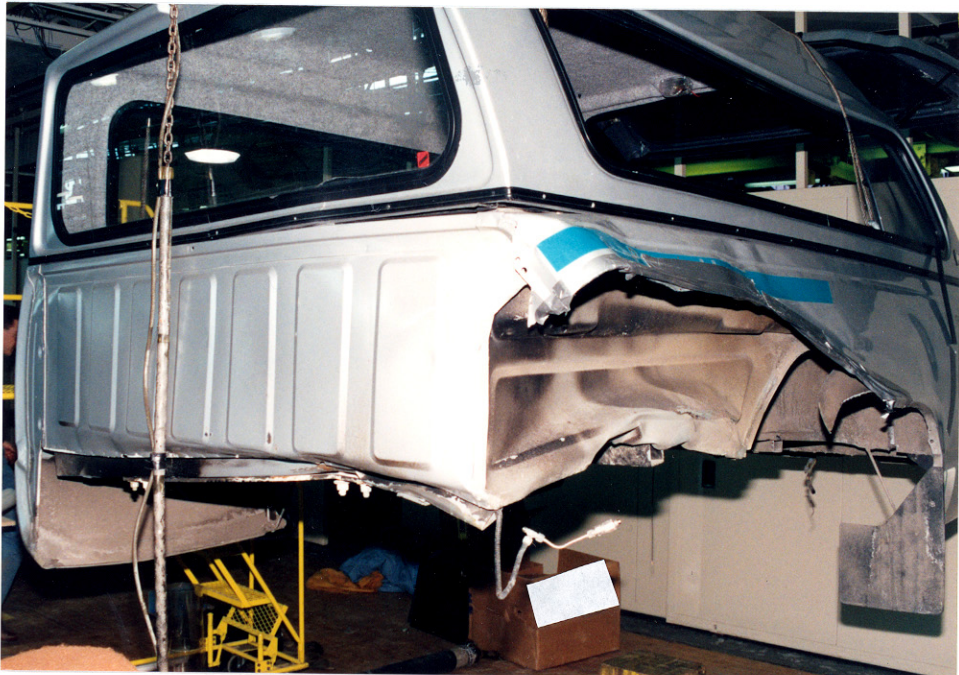
6. Left side of the cargo bed showing the damaged side panel resulting from the CNG tank failure and post event alteration

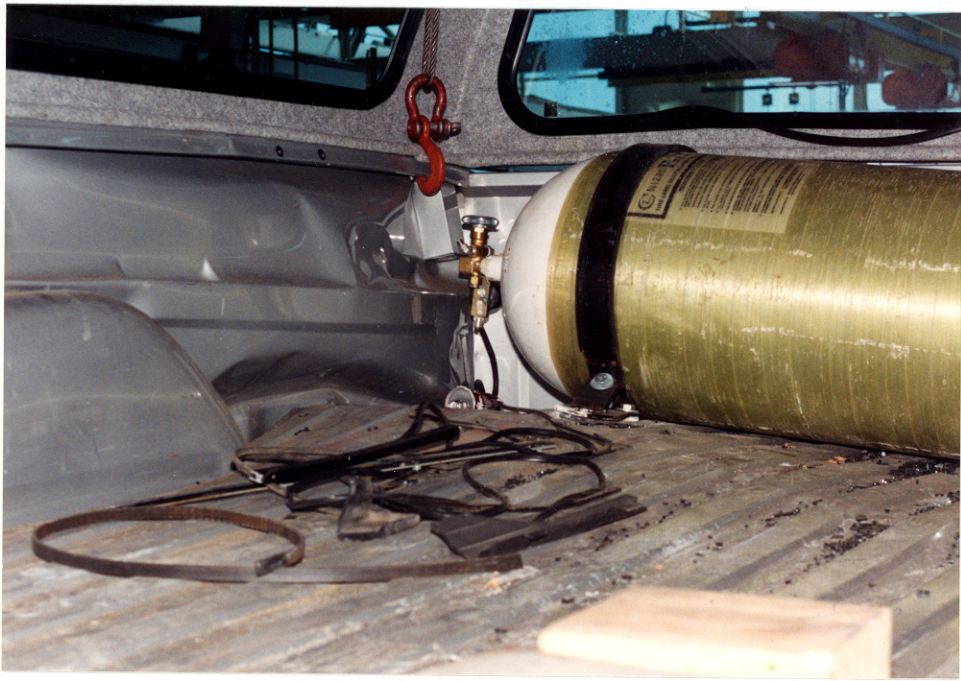
13. Angular view of the add-on tank from the right side showing deformation resulting from the CNG tank failure

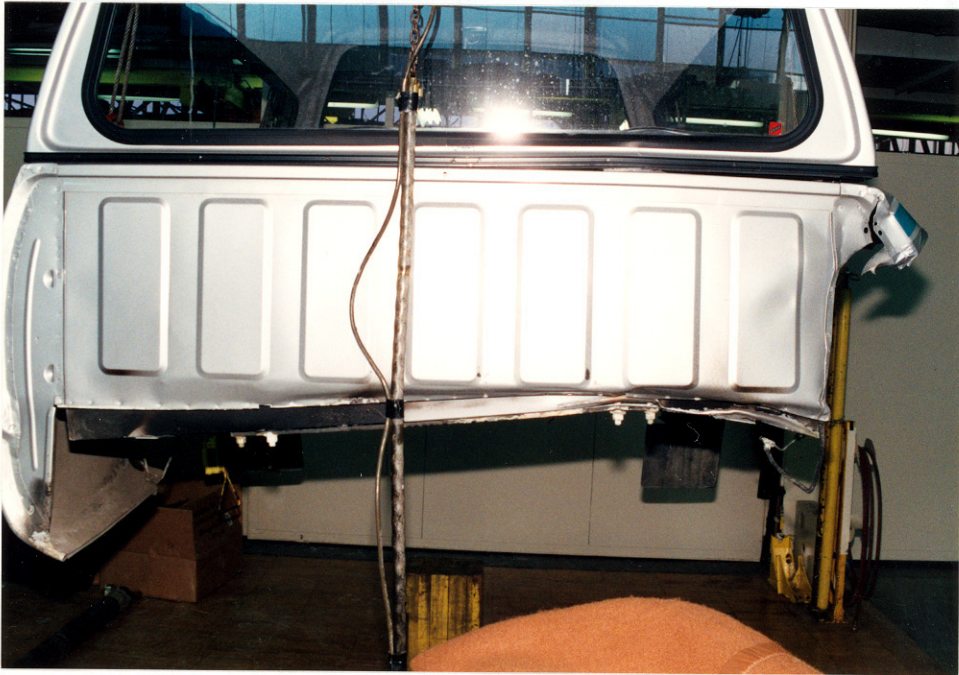
15. Frontal view of the cargo box and cap showing upward deformation along the left side from the CNG tank failure

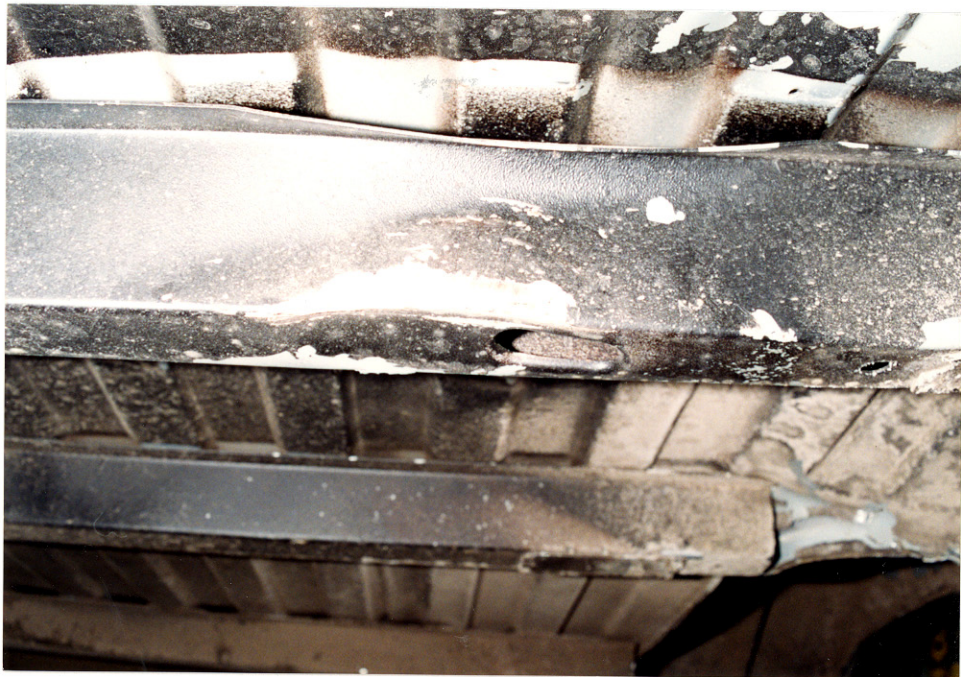
18. Close-up view of the cargo bed transverse strut showing the indentation from contact by the failed CNG tank

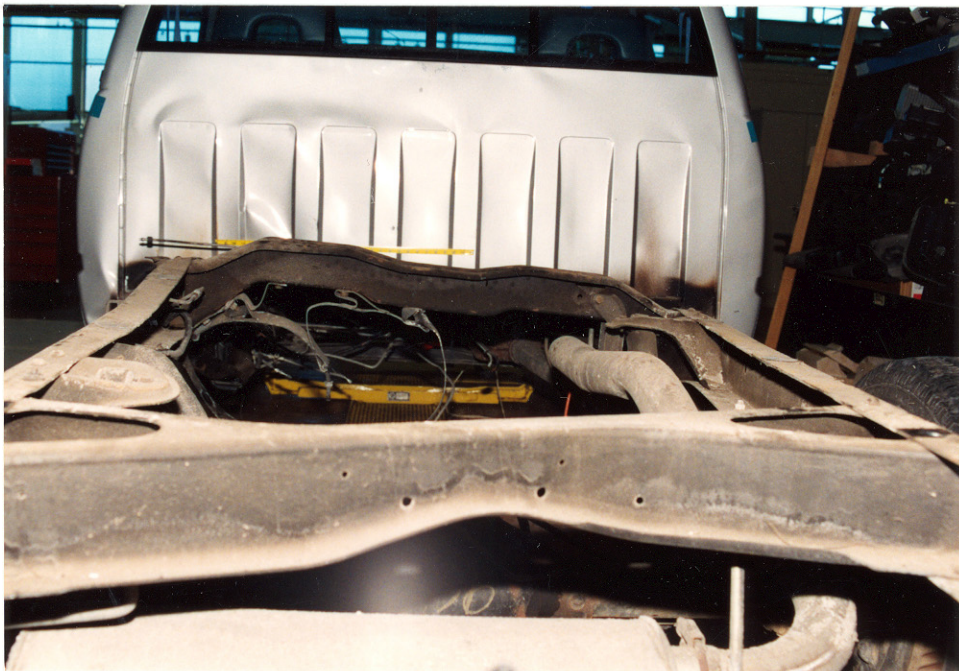
22. View of both frame rails and frame cross members illustrating the upward displacement from the CNG tank failure

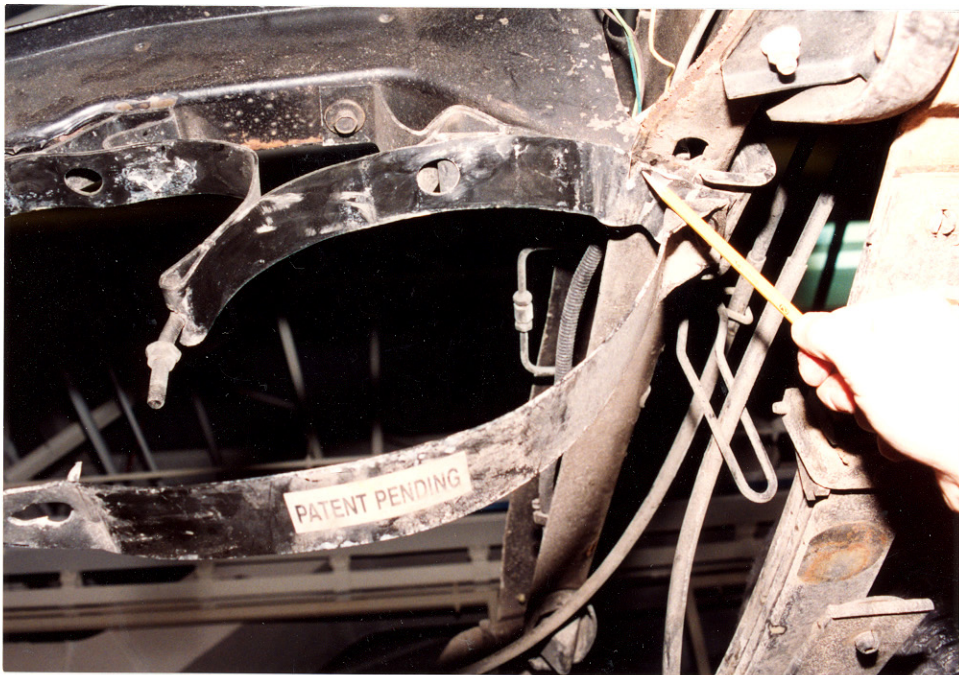
The left and center cylinders (by design) shared common lower retaining straps where the outboard ends of the straps were secured directly to the left frame rail as seen in photographs #29, #30, and #37 on pages B-16, B-20. The inboard end of the straps were bolted to frame cross members. A center nut and bolt located in the center of the straps secured the cylinders against the overhead mounting brackets. When installed, the fiberglass strap flanges of both cylinders appeared to be in contact with each other as observed during the follow-on inspection of exemplar vehicles. During the rupture sequence, the center securing nut on both the forward and rear retaining straps pulled through the metal straps.

30. Close-up view of the rear tank strap for the failed CNG highlighting a tear in the strap adjacent to the bottom flange of the left frame rail

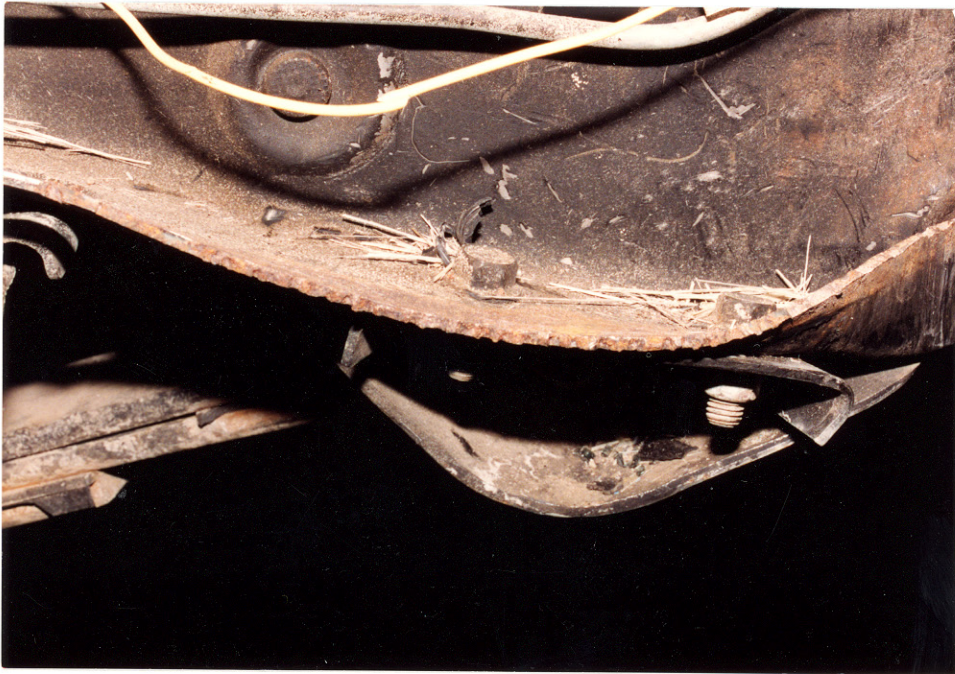
35. Close-up view of the lower flange of the left frame rail in the area adjacent to the CNG tank failure and just forward of the left spring shackle bolt highlighting conversion alteration by retrofit operations

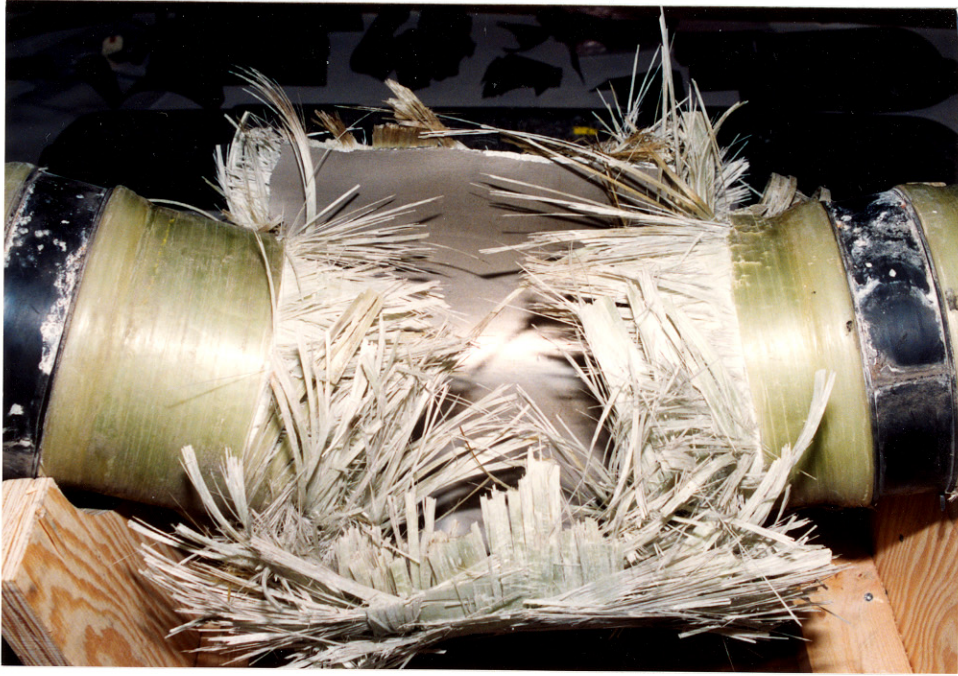
The fiberglass wrap in the area of the rupture appeared to have both a well defined blunt edge fracture pattern and an irregular pattern of shredded fiberglass strands. The blunt edge pattern appeared to be located over the site of the longitudinal aluminum liner rupture line. The shredded pattern appeared to be oriented in a 90° opposed direction along the circumferential rupture line (refer to photographs #39, #40 on page B-21).

39. Close-up view of the failed tank damage with the bottom left side of the tank along the bottom of the photograph and forward end of the tank along the right side of the photograph

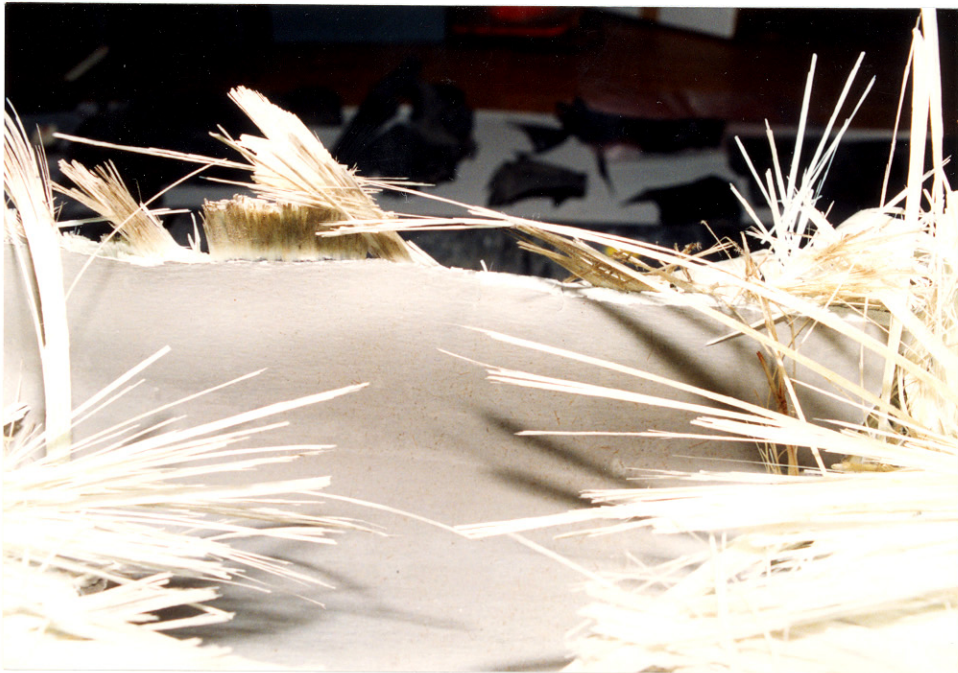
The left flap of the aluminum liner appeared to contact the vehicle's left frame rail during the fracture sequence resulting in a 5.1 cm (2.0") outward and 6.4 cm (2.5") upward displacement of the frame rail. The aluminum liner flap was observed during inspection to be irregularly shaped with at least two fragments separated from the cylinder (photographs #48-#51 on pages B-25-B-27 illustrate one of these fragments). The right flap exhibited a more symmetrical rupture pattern with a relatively straight edge configuration along the longitudinal edge. However, this edge appeared to be bevelled in opposite directions with the forward half of the flap bevelled inward and the rearward portion bevelled outward as shown in photograph #40 on page B-21.

40. Close-up view of the failed tank edge looking at the right side of the tank with the forward end toward the right side of the photograph

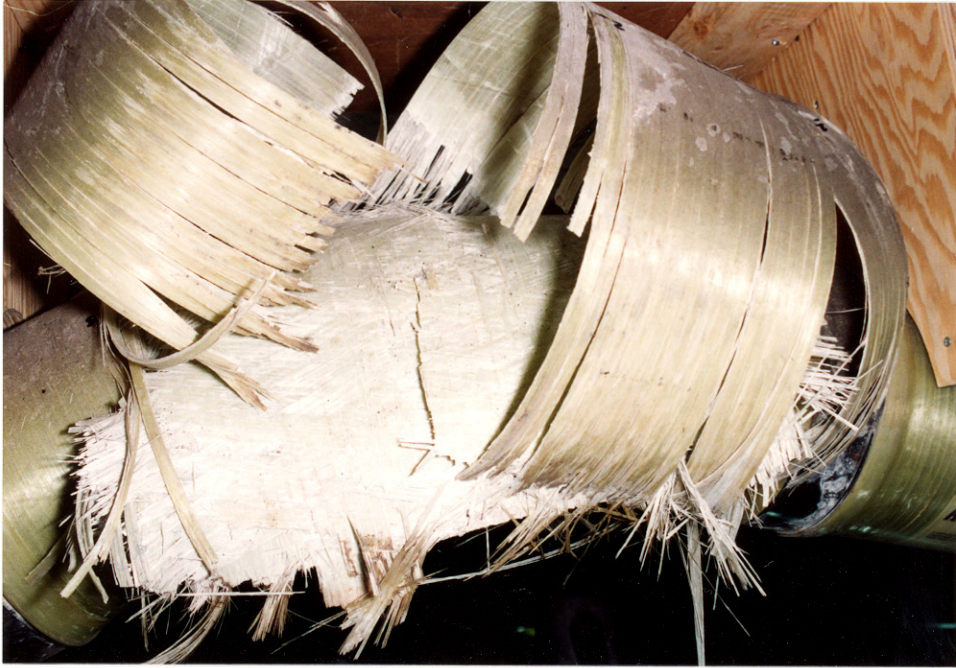
41. View of the top right side of the tank showing the fracture of the composite wrap with the forward end of the tank toward the left side of the photograph

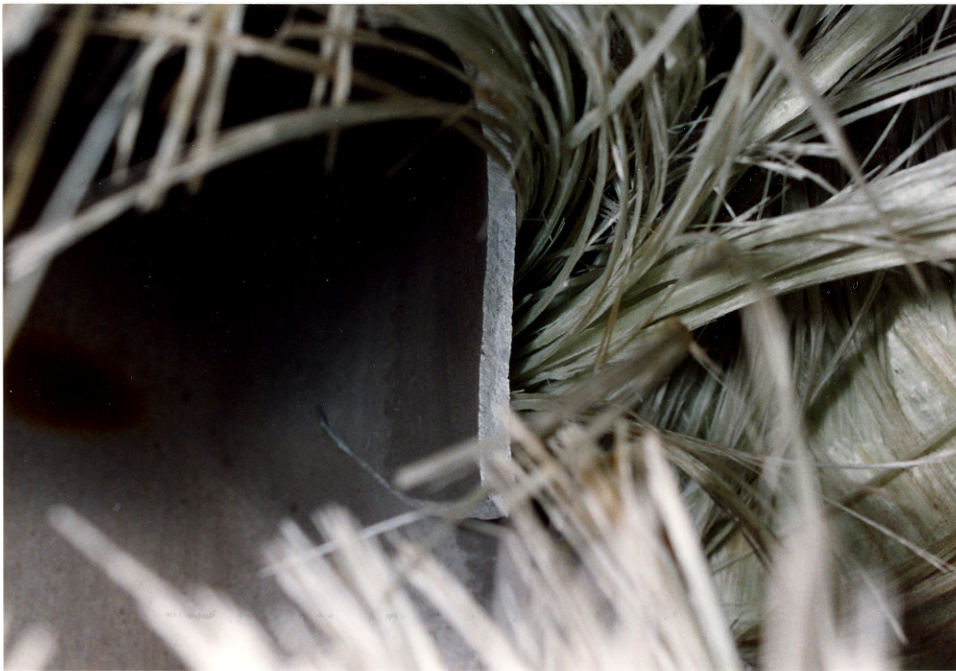
43. Close-up view of the aluminum tank along a fracture line

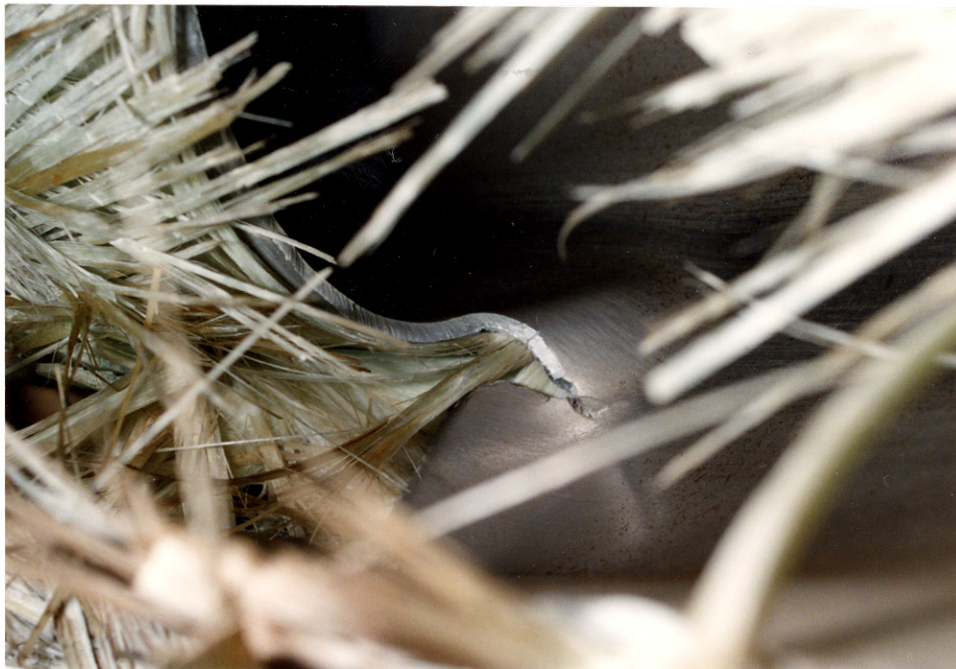
44. Close-up view of a fracture line in the aluminum tank along the bottom left side

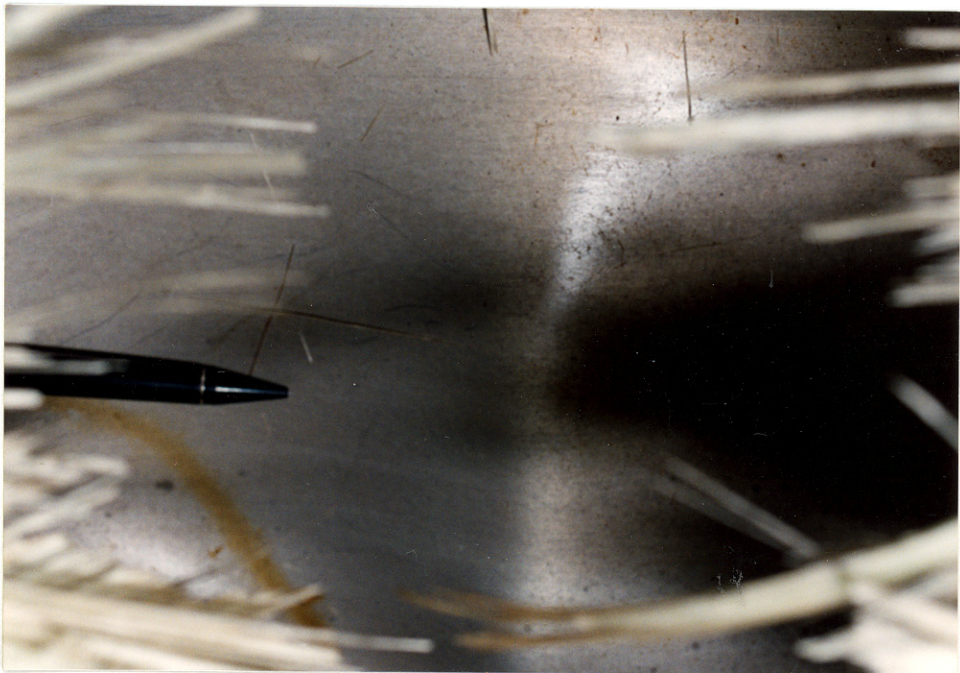
46. Overhead view of the inside of the failed CNG tank highlighting an inward displacement (kink) of the aluminum tank surface with the forward end of the tank toward the left side of the photograph

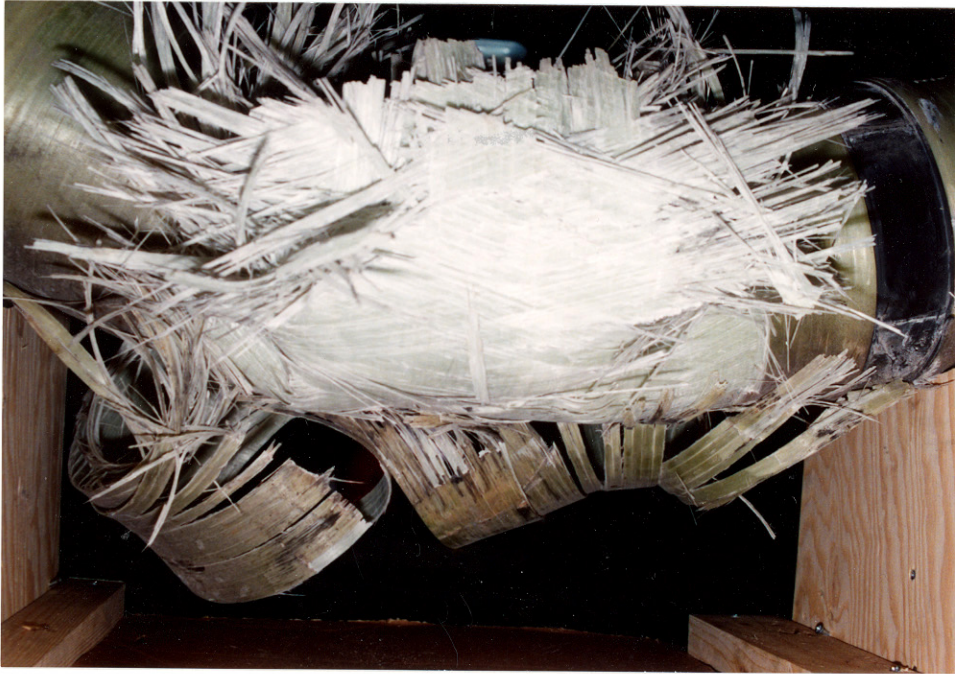
47. View of the top left surface of the fractured composite wrap looking toward the forward end of the tank along the right side of the photograph
